## OTIS ELEVATOR ISOLATION SOLUTION The Metropolitan Boston

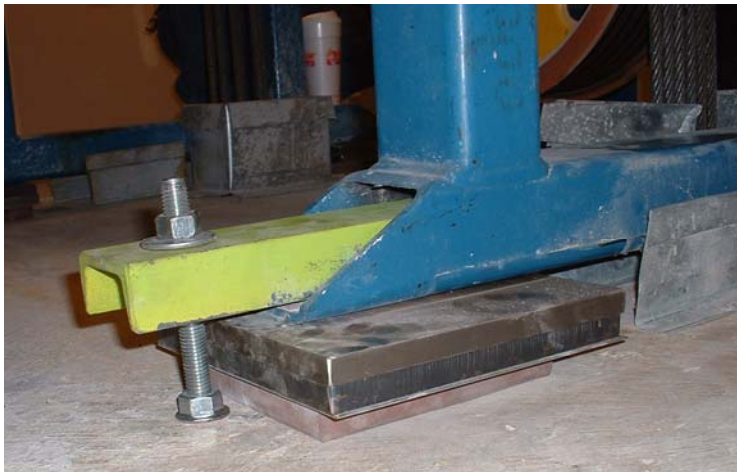
New FAB-EPM isolation material under elevator equipment.

Due to the floor response at 11 Hz, an isolation material with a natural frequency (stiffness) of 8 Hz or lower was required to provide a reduction in structural vibration/ floor response. Fabreeka replaced the existing, stiff isolators with FAB-EPM isolation material, which has a natural frequency of 7 Hz.

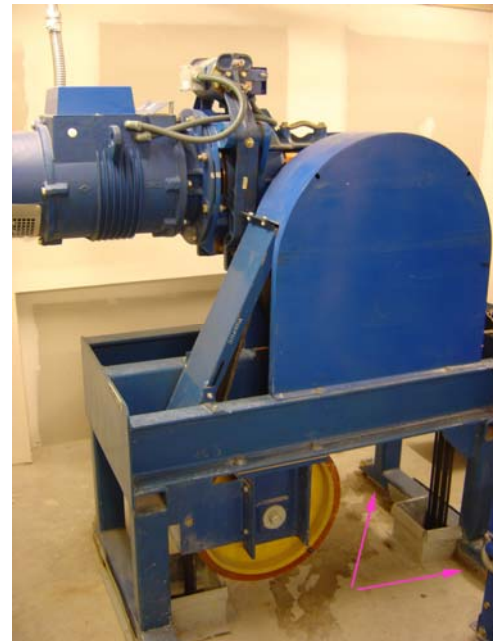
In addition to isolating the primary vibration transmission path, the use of isolation washers and bushings are recommended. This ensures protection against secondary paths of energy transfer.

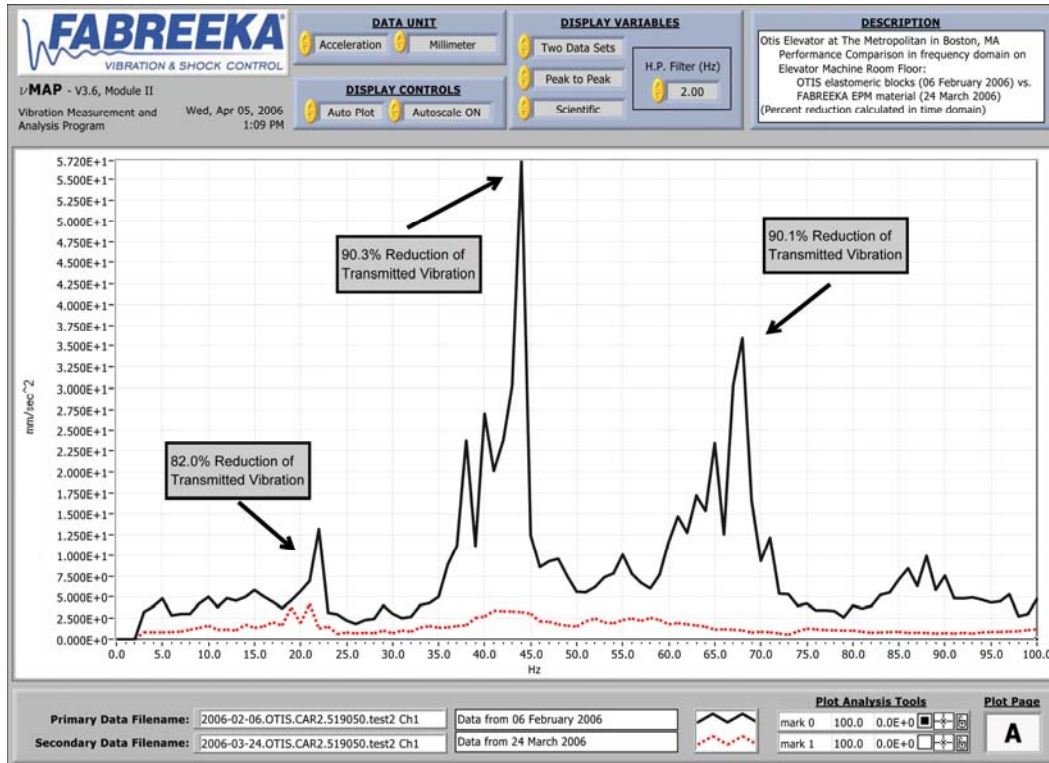
After installing Fabreeka's EPM material, vibration measurements were made to determine actual vibration reduction. There was an 82 to 90% reduction of transmitted vibration with the new isolation material.
